SONY

| Ref. No. | | | |
|---|---|---|---|
| Earpad Repair procedure change | | | |
| MDR-1R | CE7 | ALL | Black |

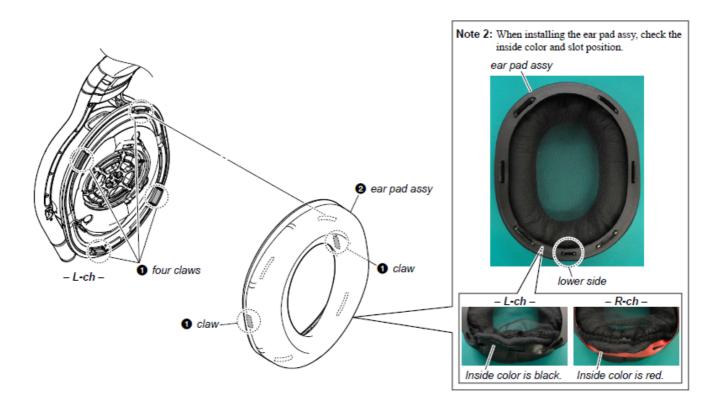
EAR PAD ASSY

1. Remove the ear pad from the main unit.

Note: Please work carefully so as not to damage the plate when removing it

Note 1: L-ch and R-ch can be similarly disassembled.

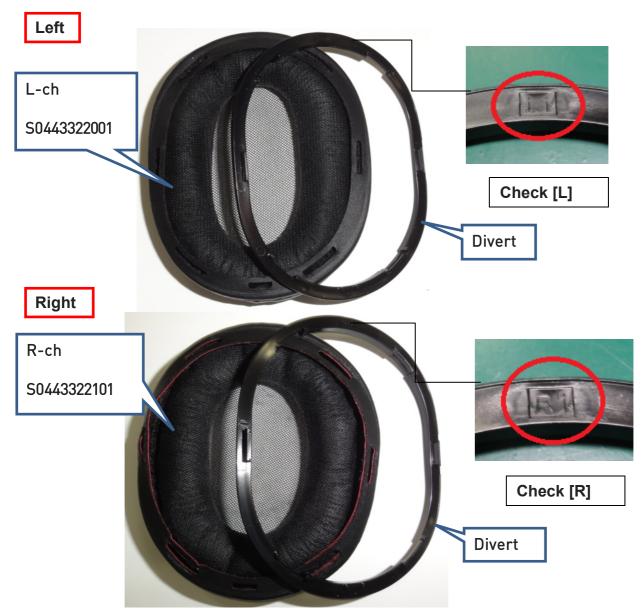
3. Attach the removed plate to the new cushion.

Note: Check the engraving of the plate part [L/R] and attach a new cushion part to combine.

2. Disassemble the ear pad into a cushion and a plate.

Note : Please be careful not to scratch as the plate will be diverted.
